**CHARACTERIZATION OF MICROSCOPIC IMPACT DAMAGE IN  
CFRP LAMINATES WITH TOUGHENED INTERLAYERS**

A thesis submitted in fulfillment of the requirements  
for the degree of  
Doctor of Engineering  
in Graduate School of Science and Engineering  
Ehime University

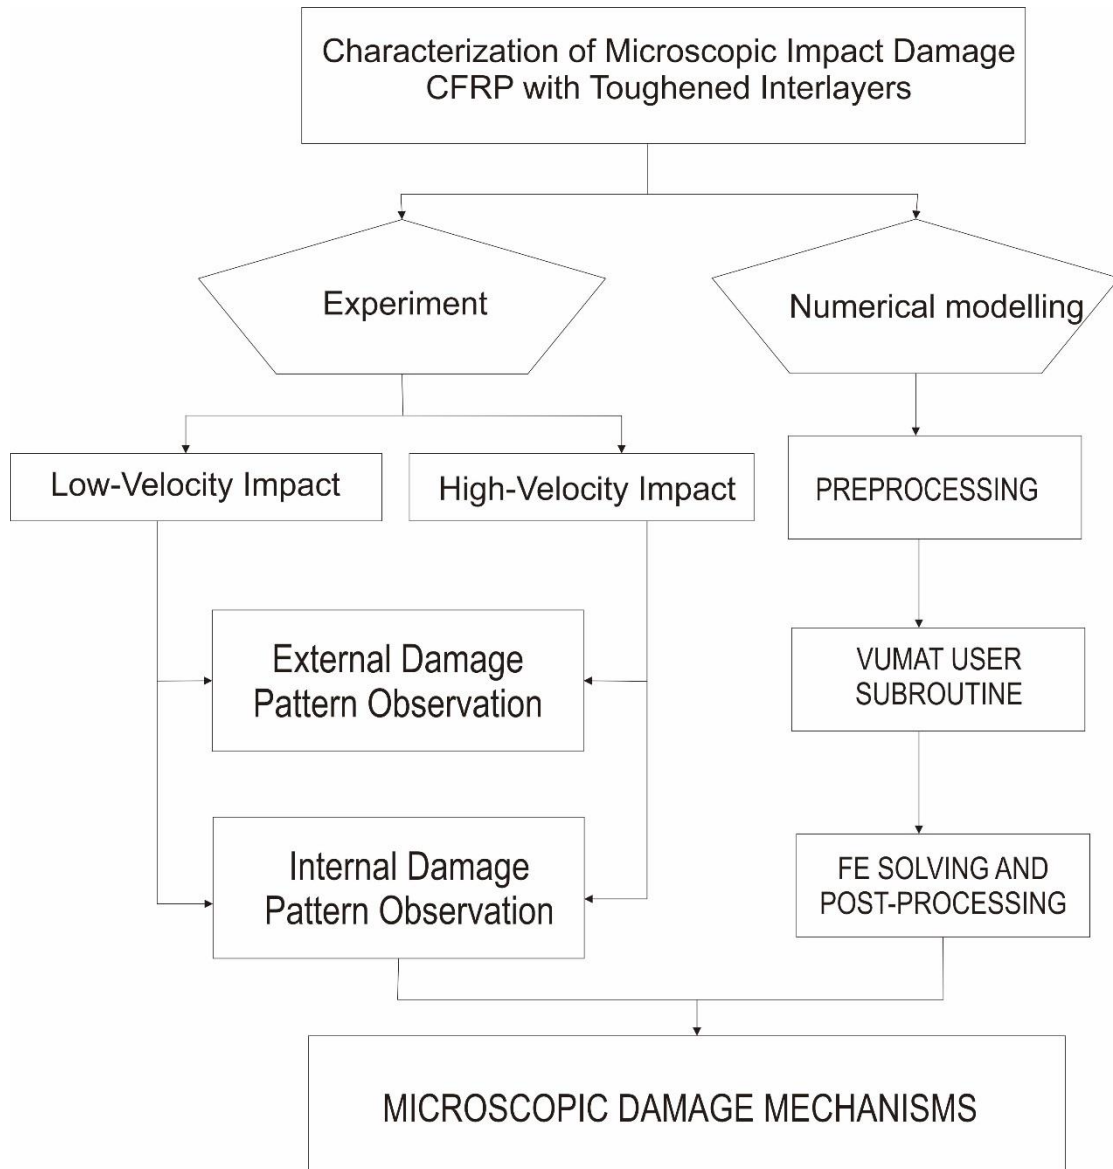
Figure 1.3: Overall research methodology.

The overall research methodology is depicted in Figure 1.3.

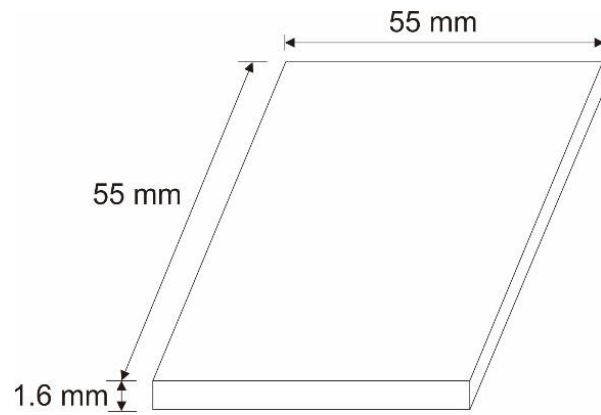
Figure 2.1: Schematic diagram of the specimen.

The material used in this study was T800S/3900-2B manufactured by Toray Industries Inc. It is a type of CFRP laminate toughened with the interlayers. The fiber strength of this material is about 10% higher than that of T800H/#3900-2. The stacking sequence was cross-ply lamination  $[0^0/90^0]_{2s}$ . Hereafter, the top and bottom plies are denoted as  $0^0$  plies. The total thickness of a cured laminate was 1.6 mm. The laminates were cut into square specimens of 55 mm wide and long by using diamond saw cutter equipped with diamond blade. Figure 2.1 depicts the schematic diagram of the specimen, whereas Figure 2.2 depicts the diamond saw cutter.

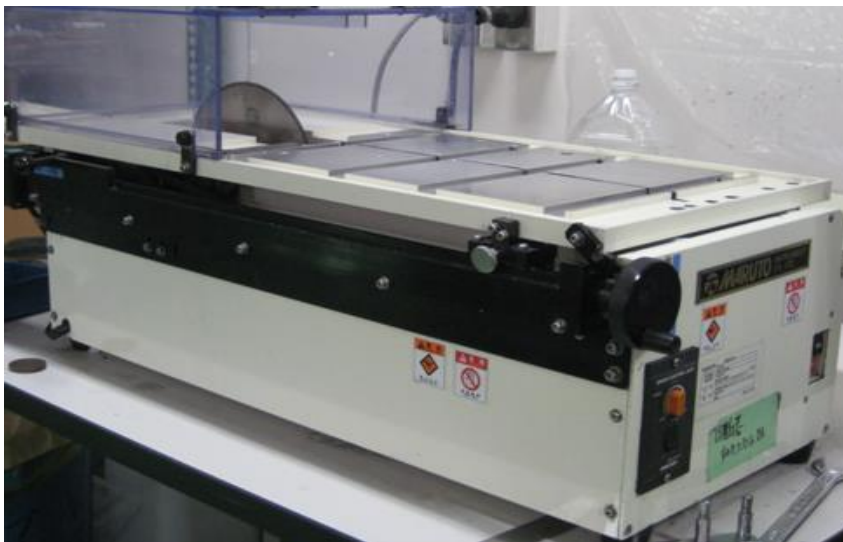
Figure 2.2: Diamond saw cutter.

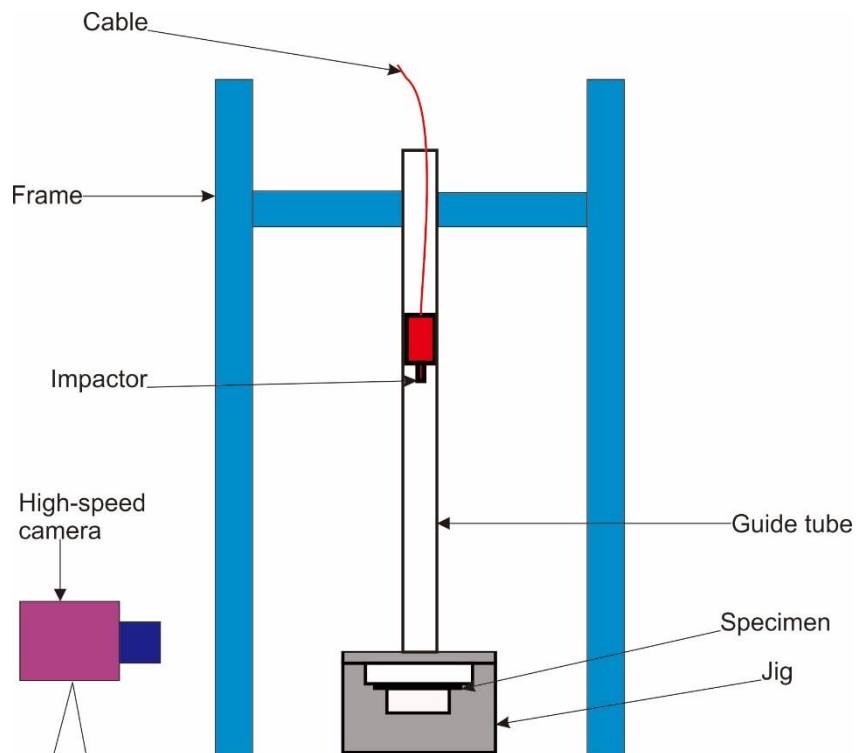
Figure 2.4: Schematic diagram of drop-weight test jig for low-velocity impact test [65].

Low-velocity impact test was conducted by using a guided drop-weight test jig illustrated in Figure 2.4. The impactor consists of a 15 mm diameter circular rod and a 1.5 mm diameter circular rod with the hemispherical tip whose diameter is the same as the projectile diameter for high-velocity impact test. The mass of impactors used was 62 g (Figure 2.5), 70.4 g (Figure 2.6) and 150 g (Figure 2.5). The impactor with a mass of 150 g is realized by screwing the additional mass to the impactor with a mass of 62 g. During the experiment, the impactor was suspended by a cable at a predetermined height to be dropped by free fall. The stopper was inserted to prevent the impactor from multiple impacts onto the specimen.

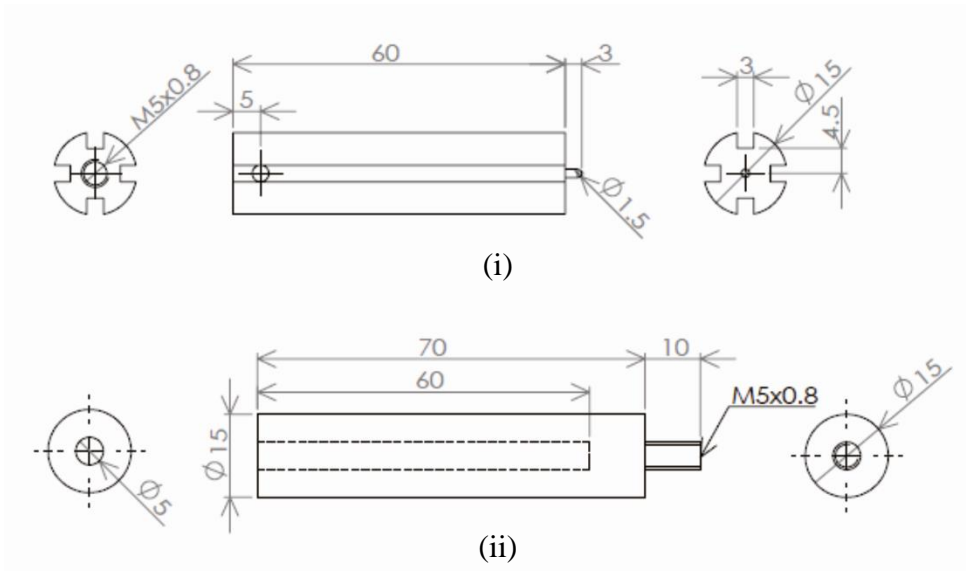
Figure 2.5: Illustration of (i) the impactor (62 g) and (ii) the additional mass (unit: mm) [65].

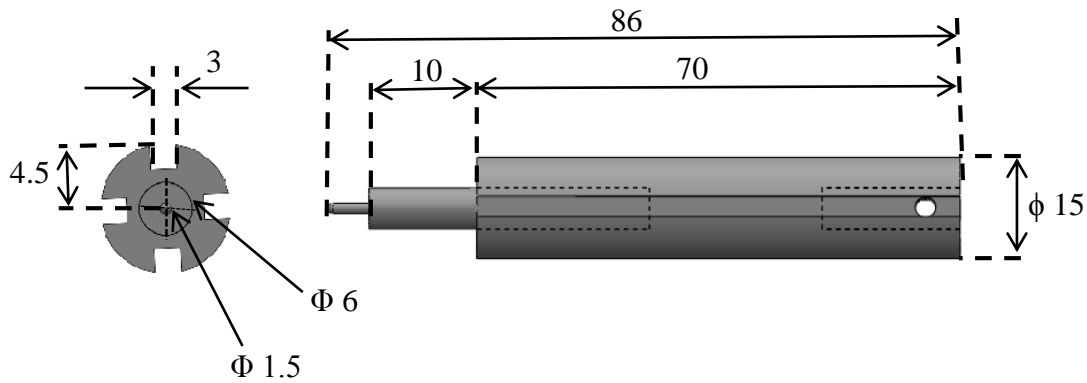
Figure 2.6: Illustration of the impactor (70.4 g) (unit: mm) [65].

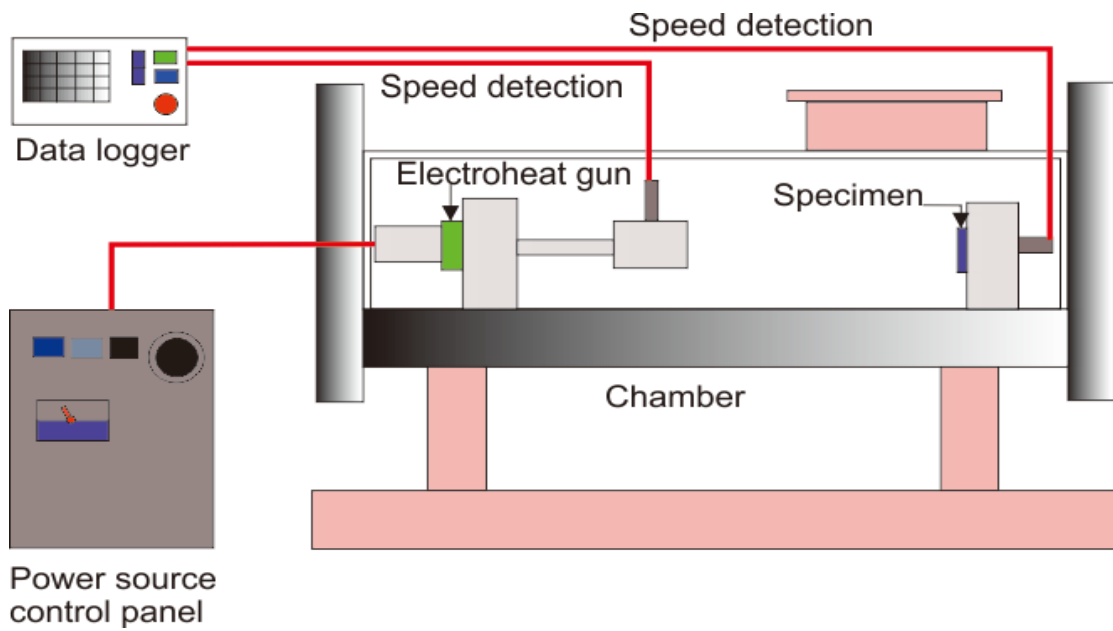
Figure 2.7: Schematic diagram of high-velocity impact testing machine [65].

Figure 2.7 illustrates a high-velocity impact testing machine (Maruwa Electronic Inc.) used in the experiment. The machine consists of a control unit for the power source and a chamber in which a projectile is fired at a target as well as a speed detector connected with a data logger. Steel balls with a diameter of 1.5 mm were used as projectiles. The projectile was set in a sabot and accelerated at high-temperature and high-pressure metal plasma. The metal plasma was generated by melting and evaporating an

aluminum foil subjected to high-voltage pulse current. The impact speed was approximately controlled by adjusting the applied voltage and precisely calculated from the period of time during which the projectile travels the prescribed distance (300 mm) in the speed detector. The velocity can be varied in the range of 40 m/s to 1500 m/s. When firing, the sabot was stopped at the opening of the gun and only the projectile was shot by inertia.

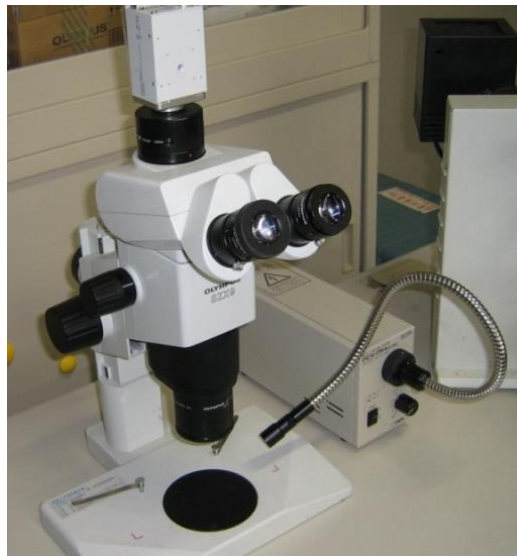
Figure 2.8: Stereoscopic microscope.

After the impact test, the damage on the specimen surface was observed by using stereoscopic microscope (OLYMPUS, SZX9) as depicted in Figure 2.8. Then, the internal

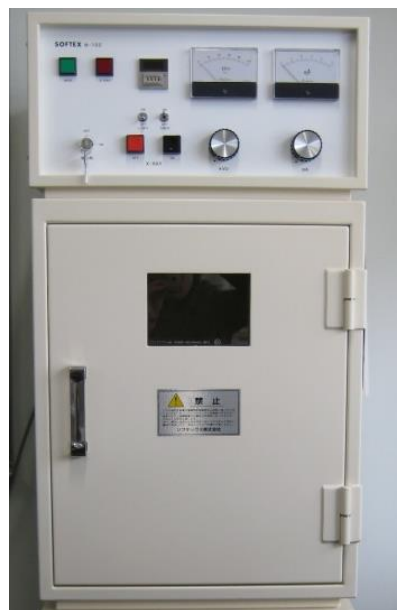
Figure 2.9: Soft X-ray radiography.

damage was quantitatively evaluated using soft X-ray radiography (SOFTEX M100) as depicted in Figure 2.9. Moreover, several specimens were cut for detail observation of the microscopic damage state on the cross-sections beneath the impact point. The observation was made by using optical microscope (OLYMPUS, BX60M) as depicted in Figure 2.10.

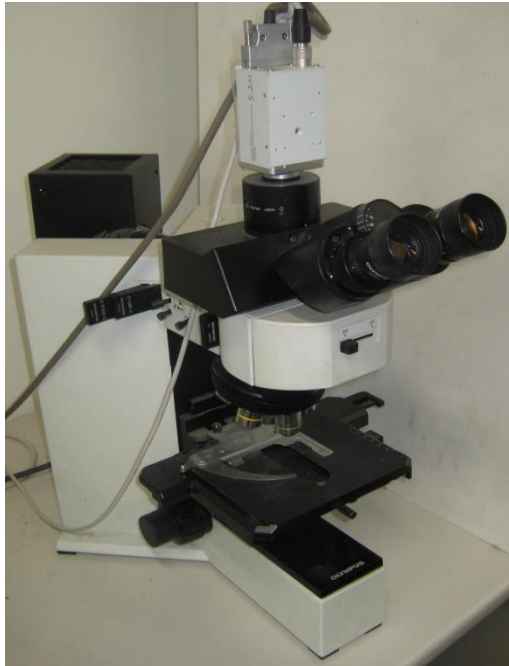
Figure 2.10: Optical microscope.

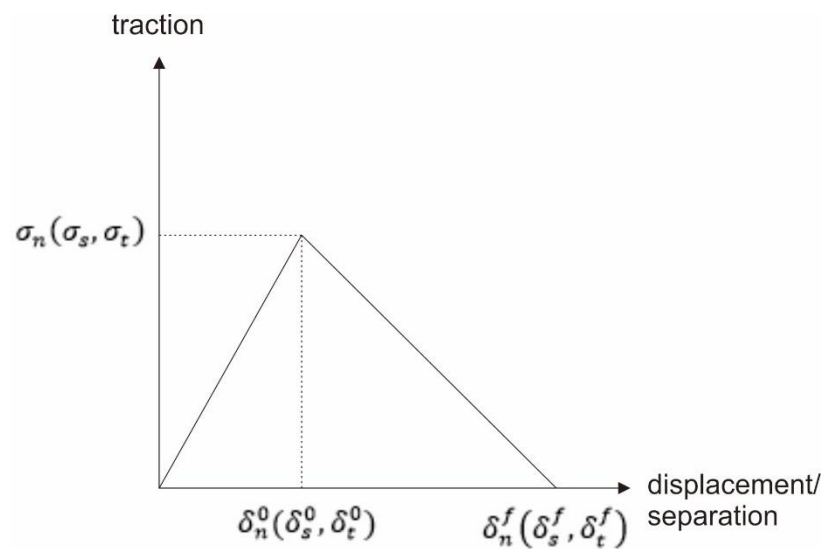
Figure 3.2: Typical linear relationship of traction-separation response for mixed-mode fracture.

and one when complete delamination generated in cohesive element. A typical linear relationship of traction-separation model for fracture modes I, II and III is depicted in the Figure 3.2. The initial response of the cohesive element is linear elastic represented by stiffness up to the interlaminar shear strength. Once it reaches the strength, the stiffness will degrade based on damage variable,  $d$  and the damage will be initiated.

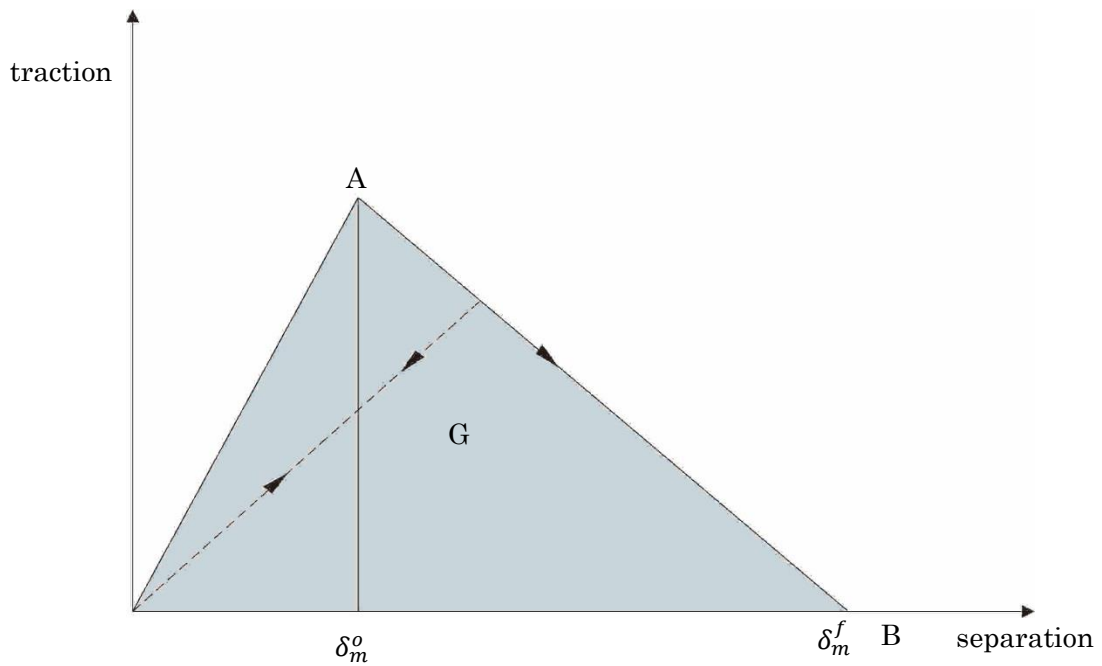
Figure 3.3: Linear damage evolution.

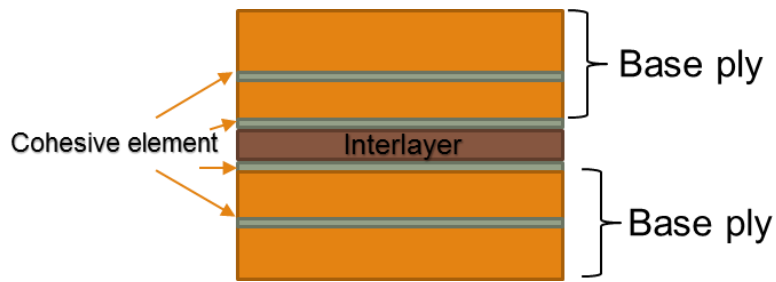
Figure 3.5: Insertion of cohesive elements in the FEA model at the interfaces of interlayer and base ply as well as within base ply [66].

A quarter model 13.75 mm square was adopted for symmetry (see Figure 3.4). The thickness of the base ply and the interlayer was 0.183 mm and 0.02 mm, respectively. 3D deformable solid body elements (C3D8R) were employed for both base plies and interlayers. In contrast, the impactor was assumed to be a rigid body with a hemispherical head whose diameter was 1.5 mm. The initial velocity was applied to the projectile to simulate the impact event. In addition, cohesive elements were introduced to express delamination generated between the base ply and the interlayer as well as inside the base plies as depicted in Figure 3.5. Hereafter, the former and the latter delaminations are

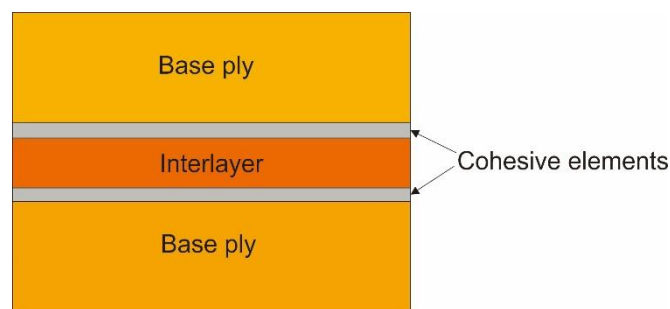
Figure 3.6: Insertion of cohesive elements in the FEA model at the interfaces of interlayer and base ply only.

On the other hand, in order to simulate the difference with and without intralaminar delamination, cohesive elements were removed inside the base ply as depicted in Figure 3.6.

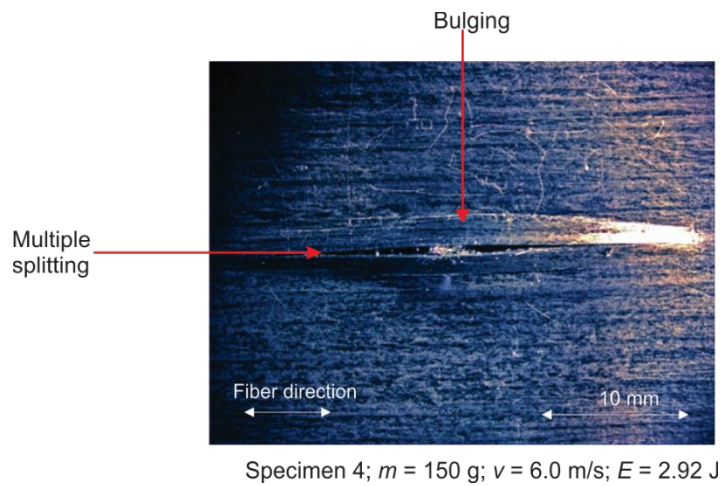
Figure 4.2: Damage on the back surface of the laminate after low-velocity impact [65].

Figure 4.1 depicts the damage generated on the front surface of the laminate at specified impact velocities and energies. A specimen with the highest velocity and energy (Figure 4.1(d)) is fully penetrated by the impactor. All the specimens except specimen 1 have a dent or a crater with two cracks propagating in the transverse (normal to the fiber) direction while any splitting cracks parallel to the fiber direction are not generated. In contrast, the splitting cracks as well as bulging area are observed on the back surface of the laminate as depicted in Figure 4.2. These cracks were generated only when the impact energy is the highest ( $E = 2.92$  J).

Secondly, the splitting cracks on the back surface is observed for both impacts when the impact velocity or energy is high (Figures 4.2 and 4.5). In the low-velocity impact, the global deformation of the laminate produces bending cracks in the bottom ply, which appears as the splitting cracks with bulging on the back surface. On the other hand, in the high-velocity impact, local bending-induced tensile stress causes multiple splitting cracks together with fiber breakage on the back surface [33].

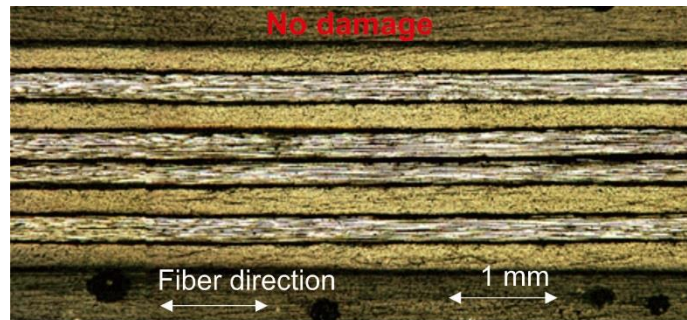
(a) Specimen 1;  $m = 62$  g;  $v = 2.4$  m/s;  $E = 0.18$  J

Figure 4.4: Damage states beneath the impact point of the laminate after low-velocity impact [65].

90° plies. It should be noted that the fiber directions in the top and bottom plies are normal to the photographs. Figure 4.4(a) depicts the cross-section of the specimen 1 for  $v = 2.4$  m/s and  $E = 0.18$  J. No internal damage is observed. Figure 4.4(b) depicts the damage state beneath the impact point for  $v = 4.9$  m/s and  $E = 0.74$  J.

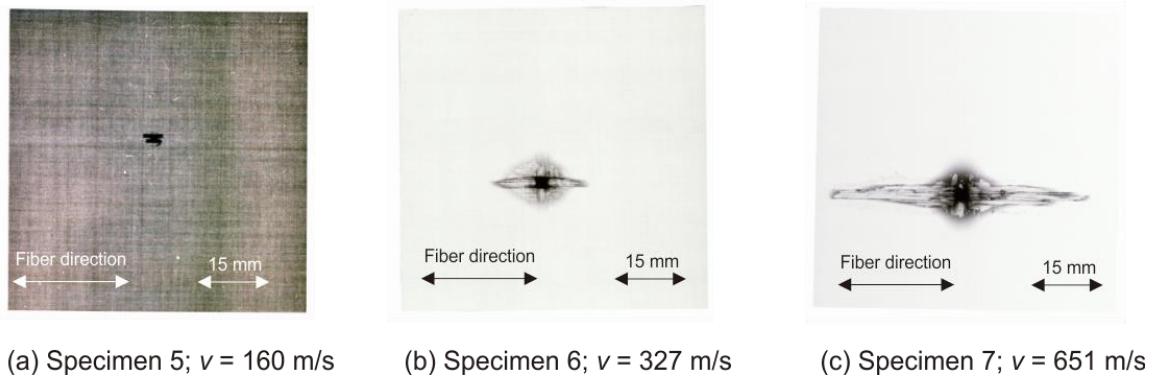
Figure 4.6: Soft X-ray photographs of the laminates after high-velocity impact [65].

Figure 4.6 presents soft X-ray photographs of the specimens after the high-velocity impact test. The fiber direction of the top and bottom plies is indicated by the arrow. At lower velocities (Figures 4.6(a) and (b)), the difference of delamination length between the fiber and transverse directions is minor. However, in the specimen after full penetration (Figure 4.6(c)), the delamination is in a galaxy-shape and is much longer in the fiber direction. As a result, the shape of delamination after high-velocity impact is similar to that after low-velocity impact with high impact energy.

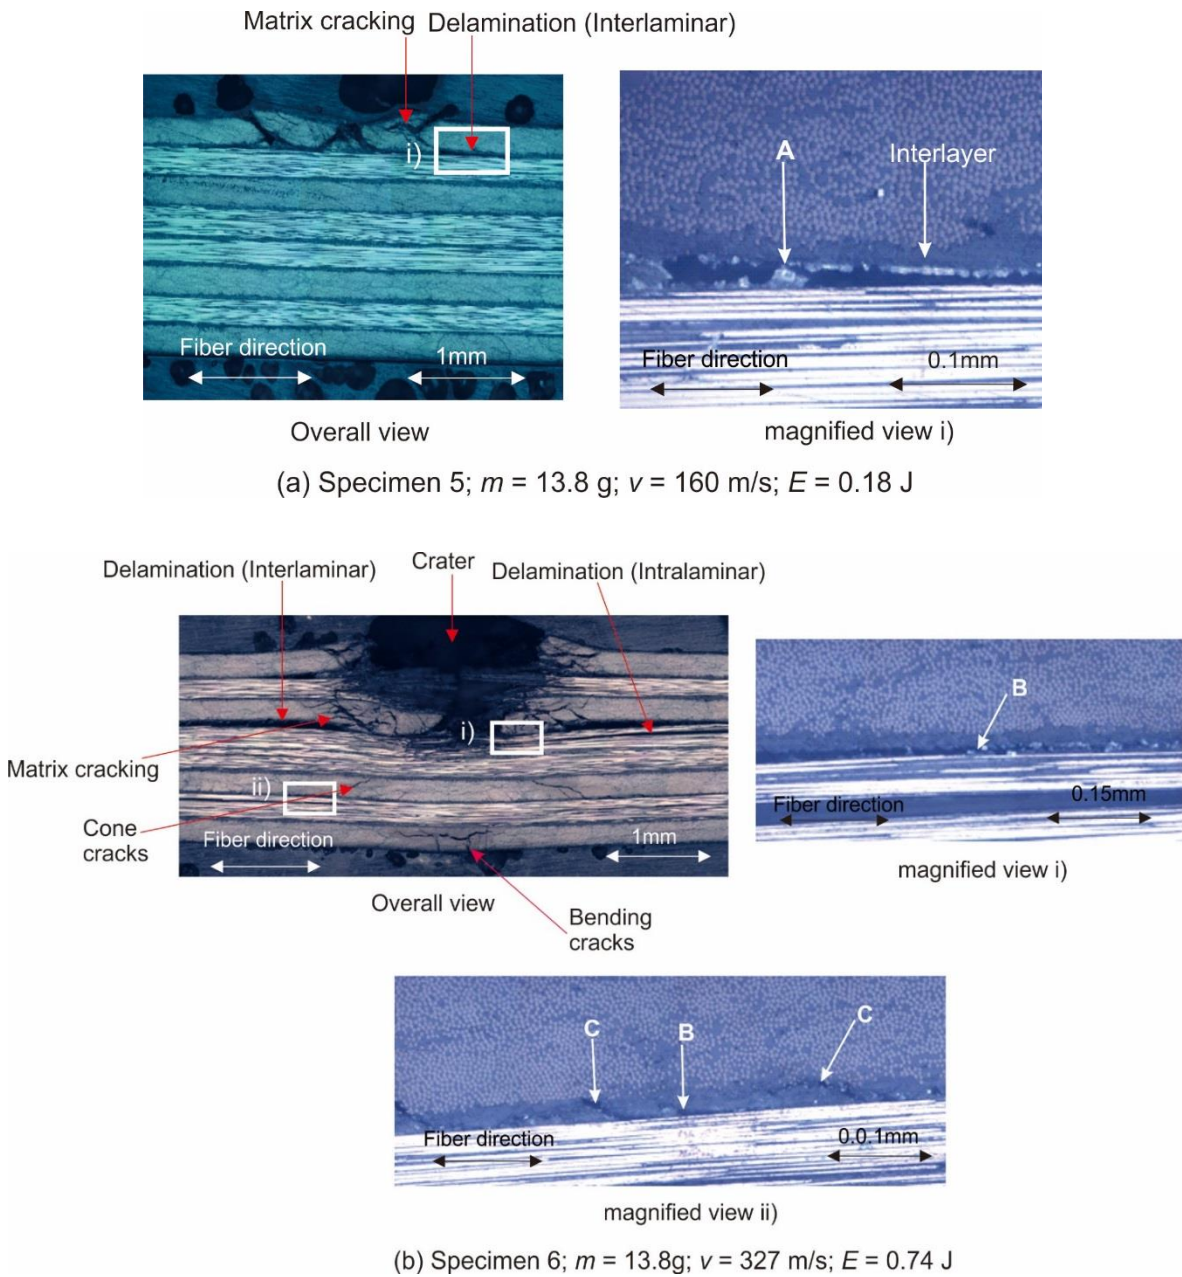
Figure 4.7: Damage states beneath the impact point of the laminates after high-velocity impact [65].

Figure 4.7 shows the cross-sectional views of the damage generated beneath the impact point for three velocities. Even when the impact velocity is relatively low (Figure 4.7(a)), both a crater and matrix cracking are observed in the top ply. In addition, the delamination is also generated at the interface between the interlayer and the base  $0^\circ$  ply (arrow A), not in the interlayer. At a middle impact velocity (Figure 4.7(b)), a crater, matrix cracking including cone cracks and bending cracks and fiber breakage are generated in all the plies. Most delaminations are generated at the interface between the interlayer and the base ply (arrows B) although several cracks are observed inside the interlayer (arrows C).

At the highest impact velocity (Figure 4.7(c)), the specimen exhibits a catastrophic damage state consisting of a crater, matrix cracking and fiber breakage as well as large-scale delamination. It is interesting to note that the intralaminar delamination is generated in the laminate at this velocity only. For example, the delamination at the interface

between the interlayer and the base ply (arrow D) is connected with the intralaminar delamination (arrow E).

As shown in Figure 4.7(c), interlaminar delamination sometimes transits to intralaminar delamination. The Mode I interlaminar fracture toughness of a similar composite laminate (T800H/#3900-2) is about three times as conventional CFRP

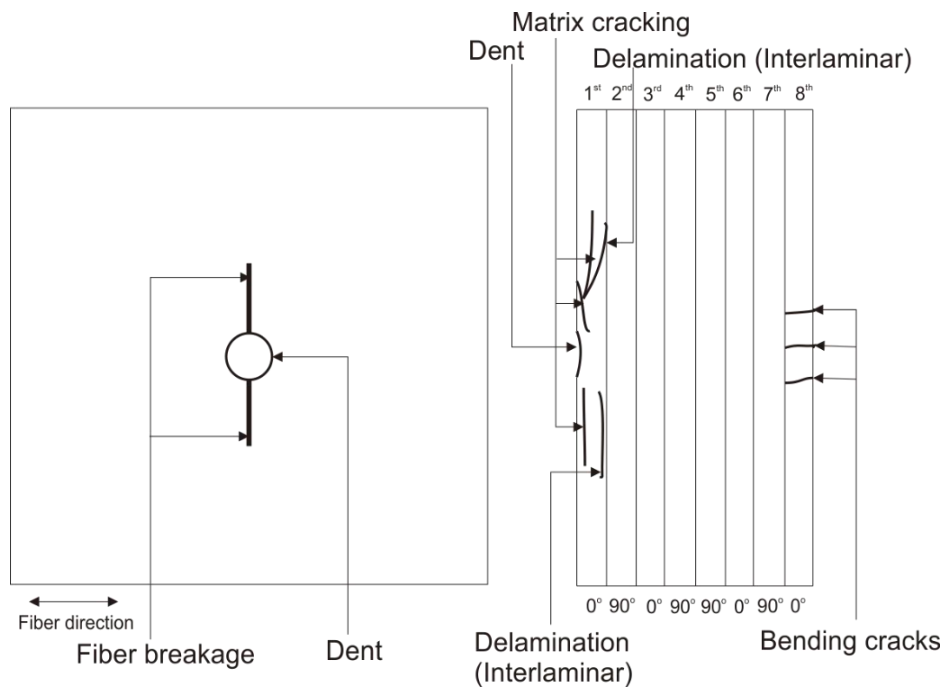
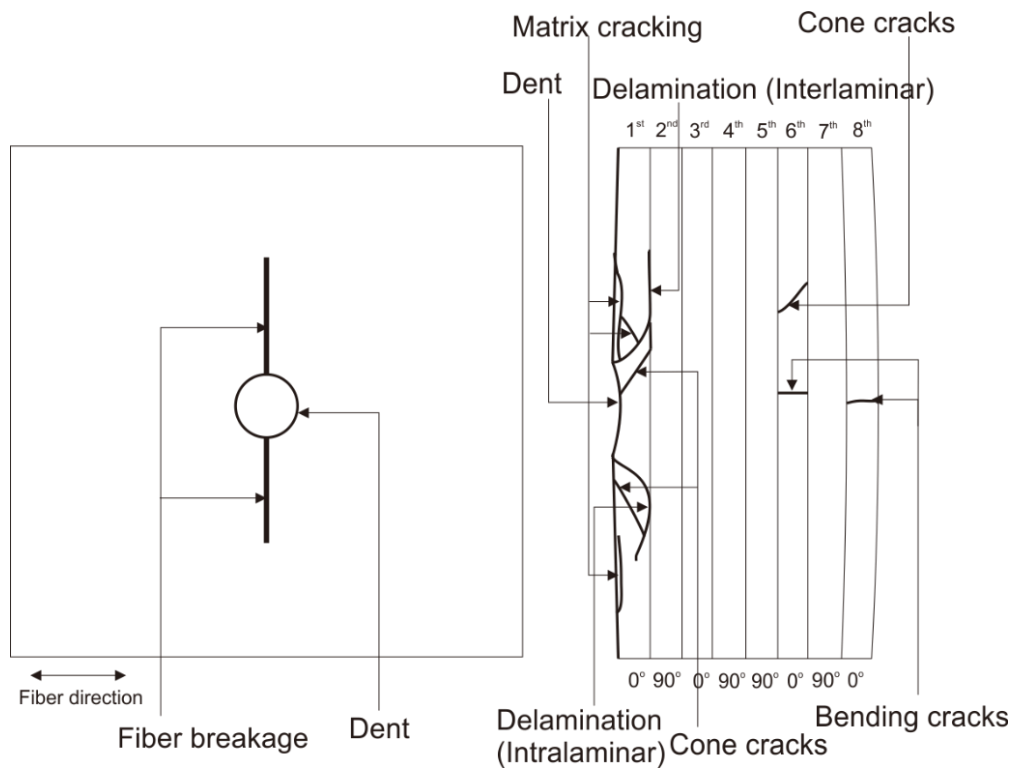
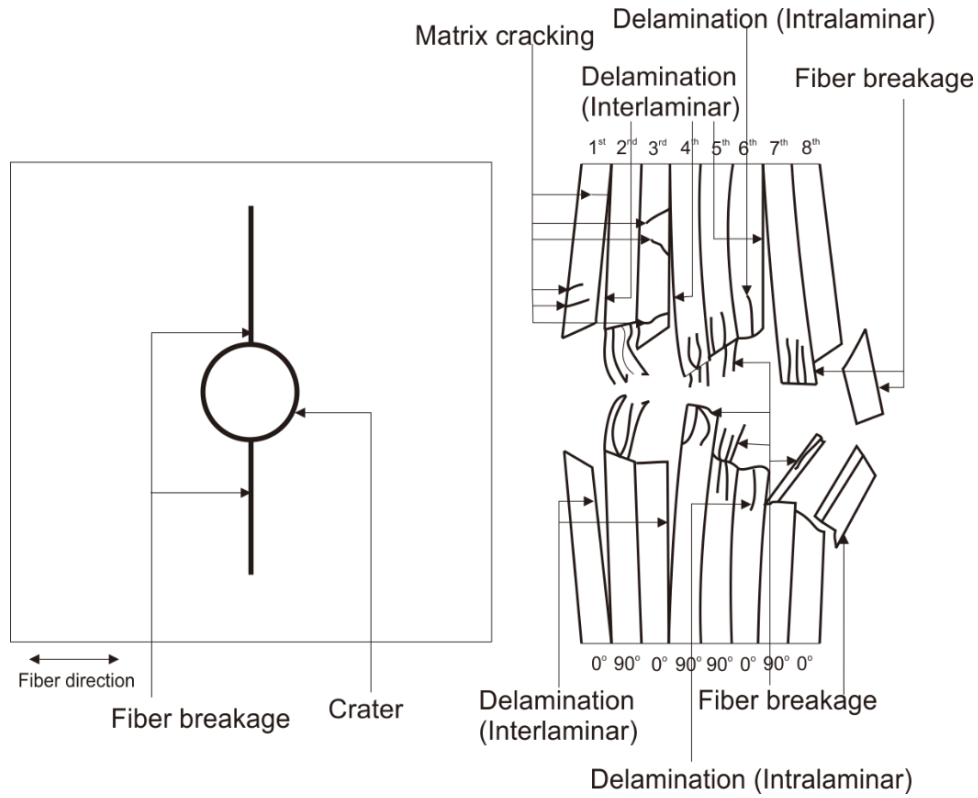
(a) Specimen 2:  $m = 62$  g;  $v = 4.9$  m/s;  $E = 0.74$  J

(b) Specimen 3:  $m = 62$  g;  $v = 6.0$  m/s;  $E = 1.13$  J

Figure 4.8: Schematic diagrams of low-velocity impact damage [65].

(c) Specimen 4:  $m = 150$  g;  $v = 6.0$  m/s;  $E = 2.92$  J

As shown in the experimental result, low- and high-velocity impacts produce different damage states. The schematic illustrations for low- and high-velocity impacts damage are depicted in Figures 4.8 and 4.9, respectively. The damage mode for low-velocity impact is almost the same as that for high-velocity impact since the damage consists of a dent or crater, matrix cracking, interlaminar delamination, intralaminar delamination and fiber breakage. The delamination shape is also similar between the both impacts although the delamination size is different as shown later.

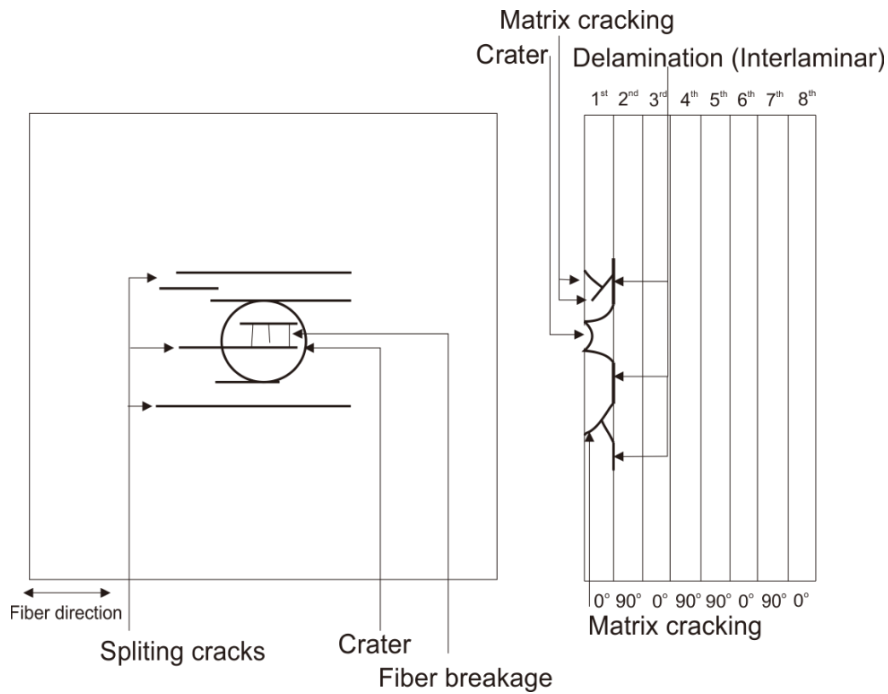
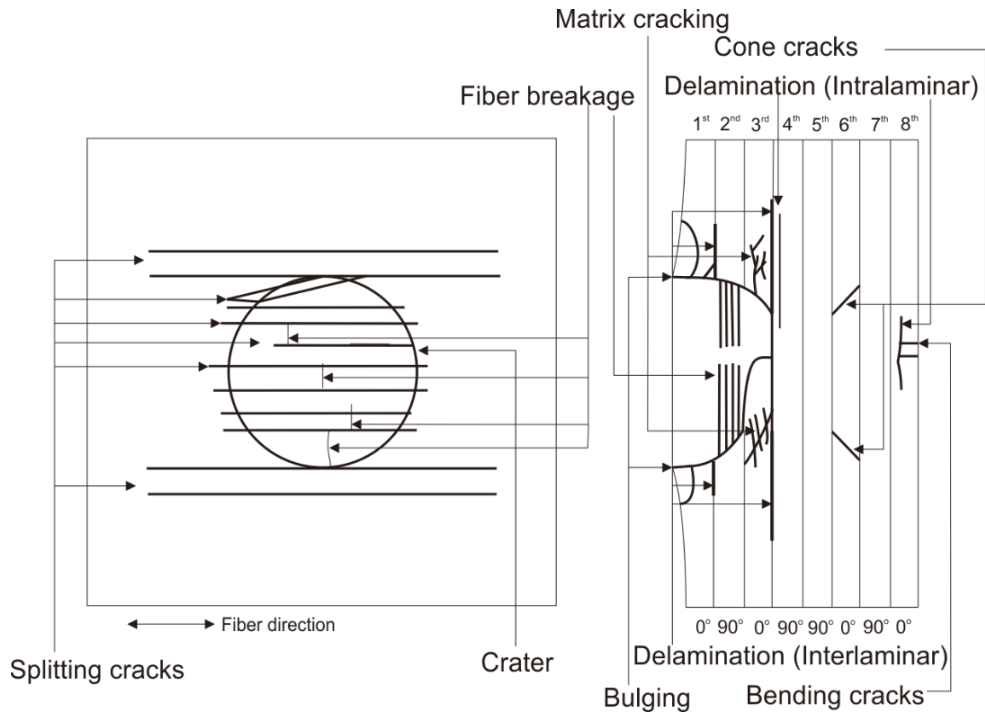
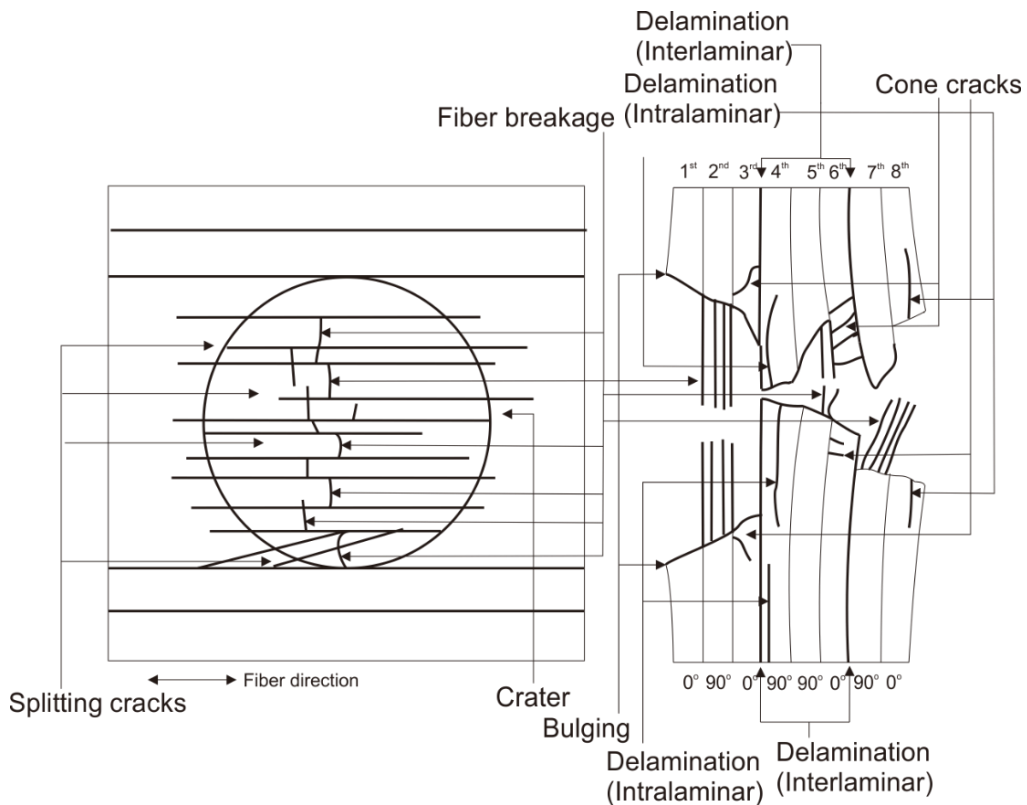
(a) Specimen 5:  $m = 13.8$  g;  $v = 160$  m/s;  $E = 0.18$  J

Figure 4.9: Schematic diagrams of high-velocity impact damage [65].

(b) Specimen 6:  $m = 13.8 \text{ g}$ ;  $v = 327 \text{ m/s}$ ;  $E = 0.74 \text{ J}$

(c) Specimen 7:  $m = 13.8 \text{ g}$ ;  $v = 651 \text{ m/s}$ ;  $E = 2.92 \text{ J}$

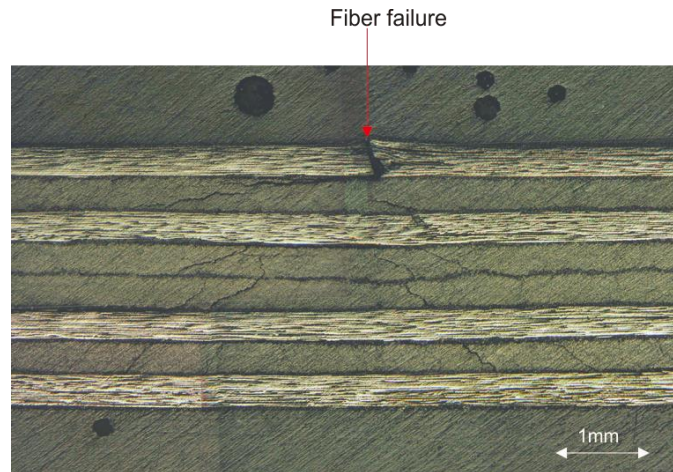
Figure 4.10: Fiber failure after low-velocity impact [65].

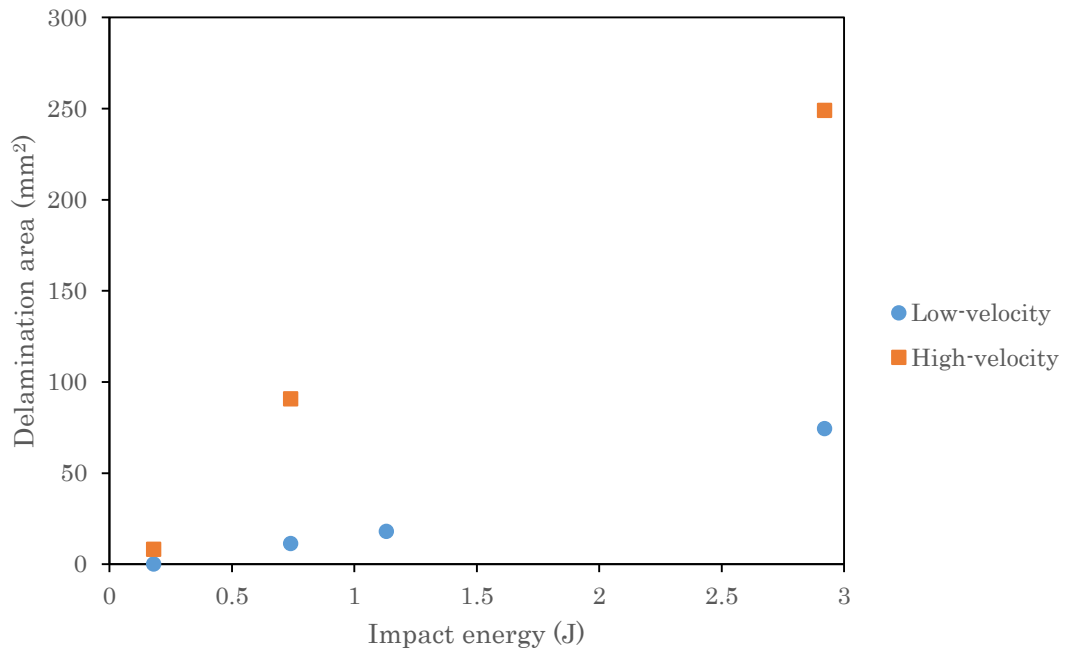
Figure 4.11: Relationship between delamination area and impact energy for low- and high-velocity impacts [65].

Finally, delamination area for both impacts is plotted against incident impact energy in Figure 4.11. The delamination area increases with impact energy for both impacts. Contribution of matrix cracking to energy dissipation is supposed to be small. Fiber breakage requires greater impact energy, however, fiber breakage area is much smaller than delamination area. Accordingly, the energy dissipation due to damage is mainly done by delamination. Moreover, as mentioned above, most part of the incident impact energy is consumed by damage generation in the high-velocity impact since the deformation is local. In contrast, the greater part of incident impact energy is absorbed by global deformation in the low-velocity impact. As a result, the high-velocity impact exhibits delamination area larger than the low-velocity impact for the same incident impact energy. In addition, Figure 4.11 indicates that the threshold incident impact energy is approximately 0.18 J for both impacts. Numerical simulation including interlayers is necessary to quantitatively discuss the damage behavior and will be made in future work.

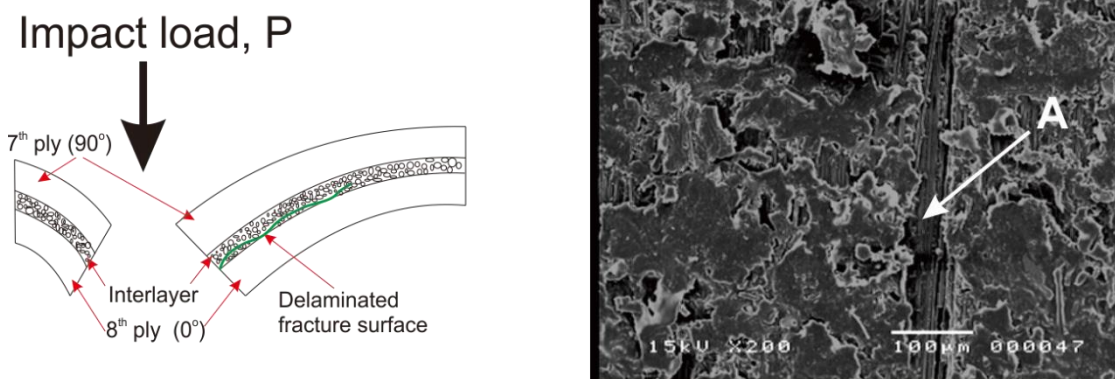
Figure 4.12: SEM photo showing the surface of delamination in the specimen after the low-velocity impact [65].

Figure 4.12 depicts the surface of delamination between the 7th and 8th plies just below the impact point in the specimen after the low-velocity impact with the highest impact energy ( $E = 2.92$  J). The resin rich region is prominent on this fracture surface although the base ply (arrow A) is partly observed. From this figure, it is concluded that the delamination propagates at the interface between the bottom (7th) interlayer and the bottom (8th) base ply. The fracture mode seems to be brittle because the surface exhibits little plastic deformation. The delamination initiation and propagation modes below the impact point are rather complicated because not only the stress state but also the damage process can affect the modes. At the present stage, it can be said from the previous numerical simulation [33] that Mode II propagation becomes dominant as the delamination propagates away from the impact point.

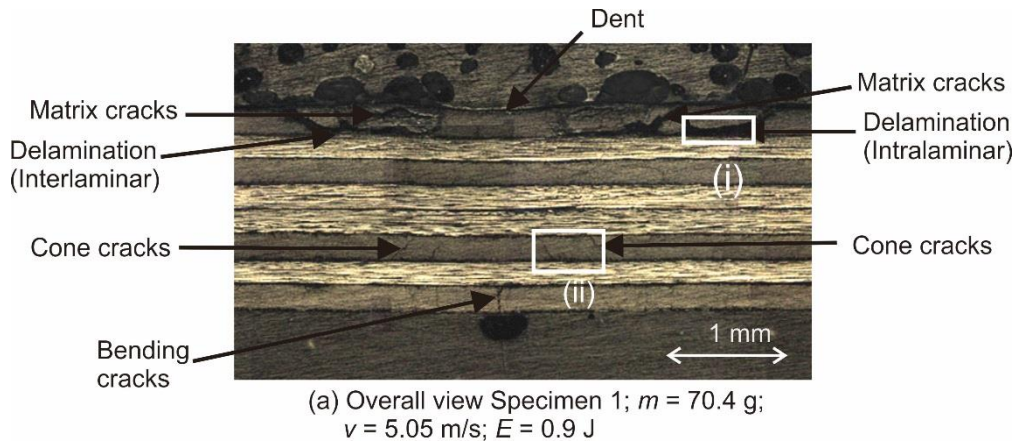
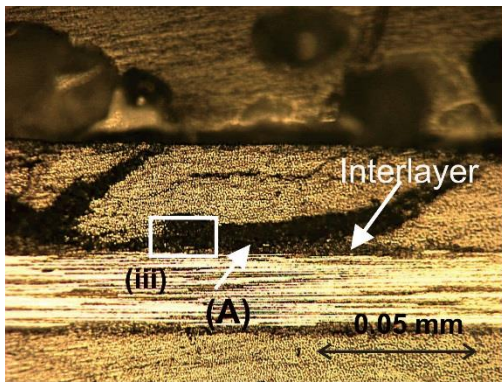
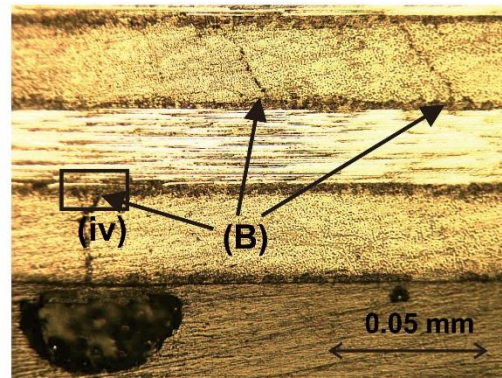
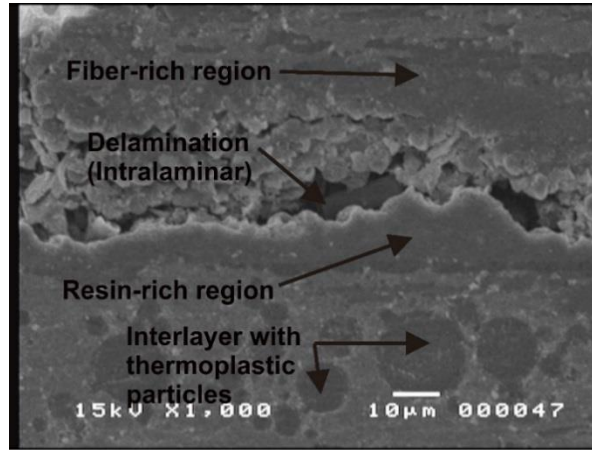
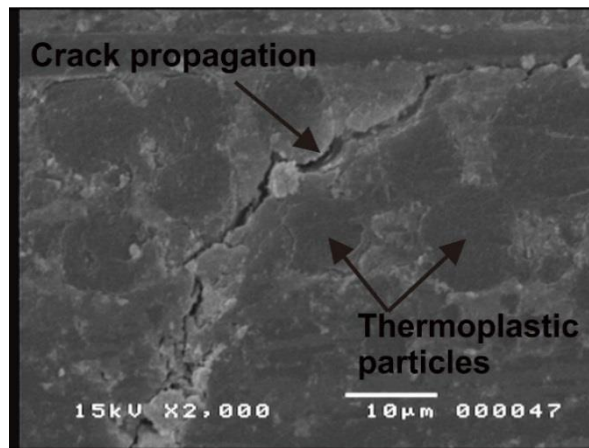
Figure 5.1: Damage states beneath the impact point of the specimen 1 laminate after low-velocity impact [66].

(d) SEM photo for the magnified view (iii)

(e) SEM photo for the magnified view (iv)

Figure 5.1 depicts the damage state generated beneath the impact point of the specimen. It should be noted that the fiber ( $0^\circ$ -) direction in the top and bottom plies of the laminate are normal to the photographs. The damage consists of a dent, delaminations

and matrix cracks including bending cracks in the bottom ply and cone cracks in the middle ply. In the top ply, both interlaminar and intralaminar delaminations are generated. The interlaminar delamination extends between the top ply and the interlayer, whereas the intralaminar one is inside the top ply (arrow A in Figure 5.1(b)).

As shown in Figure 5.1(d), the intralaminar delamination is generated between the resin-rich and fiber-rich regions in the top ply. Most of the matrix cracks stop at the interface between the base ply and the interlayer (arrow B in Figure 5.1(c)). The cracks propagate among the thermoplastic particles to make a tortuous path (Figure 5.1(e)). Consequently, the interlayer acts as a crack arrestor and a deflector.

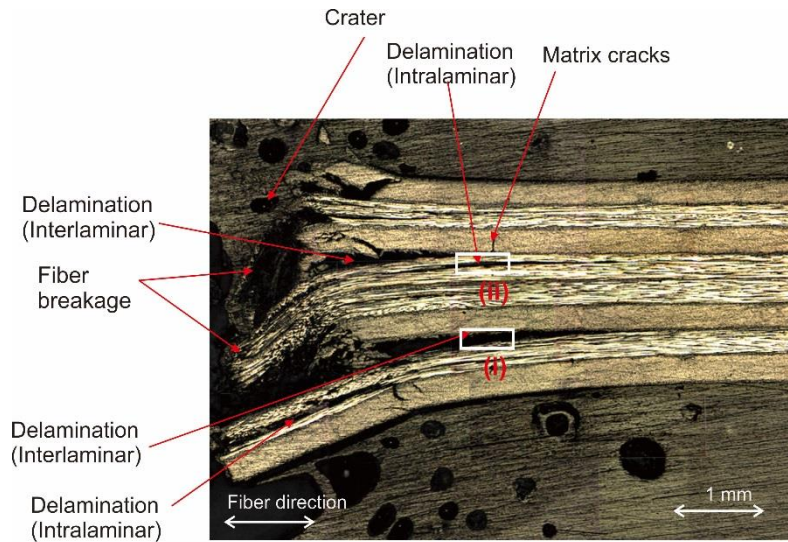
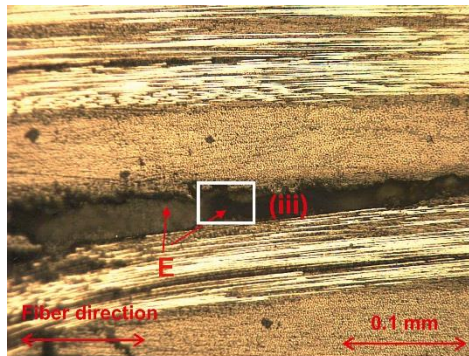
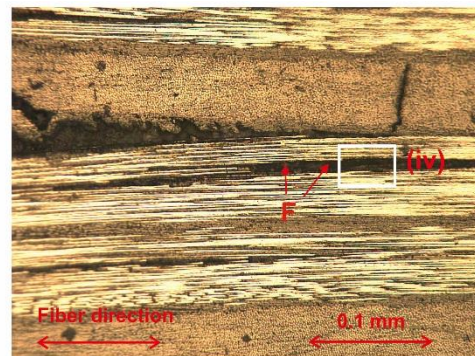
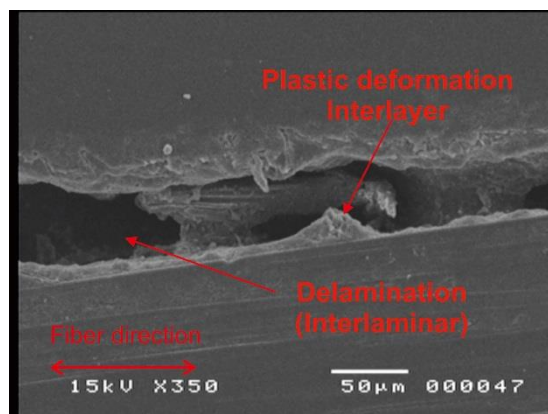
(a) Overall view Specimen 3;  $m = 150.3$  g;  
 $v = 5.94$  m/s;  $E = 2.65$  J

(b) magnified view (i)

(c) magnified view (ii)

(d) SEM photo for magnified view (iii)

Figure 5.4: Damage states beneath the impact point of the specimen 3 laminate after low-velocity impact.

Another impact damage state is depicted in Figure 5.4 with  $v = 5.94$  m/s and  $E = 2.65$

J. At this state, full penetration is generated because the impact energy is higher due to increasing mass of impactor. The top surface area of laminate beneath the impact point exhibits a crater with bulging and all plies including the interlayers break in the perforation region. In the vicinity area of penetration; fiber breakage, interlaminar and intralaminar delamination as well as matrix cracks are generated. As depicted in the magnified view (i) (Figure 5.4(b)), it is observed that the interlaminar delamination is

generated at the interface between the interlayer (bottom interface) and base ply ( $90^\circ$ ) (arrow E) and it is different from specimen 2 damage (Figure 5.3(b)) since the interlaminar delamination is generated at the interface between  $0^\circ$  ply and interlayer (top interface).

The interlaminar delamination is generated due to plastic deformation of interlayer as depicted in Figure 5.4(d). Apart from interlaminar delamination, intralaminar delamination is also slightly different from specimen 2 because the delamination is generated at base ply ( $90^\circ$ ) as depicted in the magnified view (ii) (arrow F) (Figure 5.4(c)). Consequently, the presence of the toughened interlayer generated an intralaminar delamination as it is not observed in conventional CFRP. Furthermore, the transition from interlaminar delamination to intralaminar delamination indicates high interlaminar fracture toughness in the toughened interlayer to that in the untoughened base ply [65].

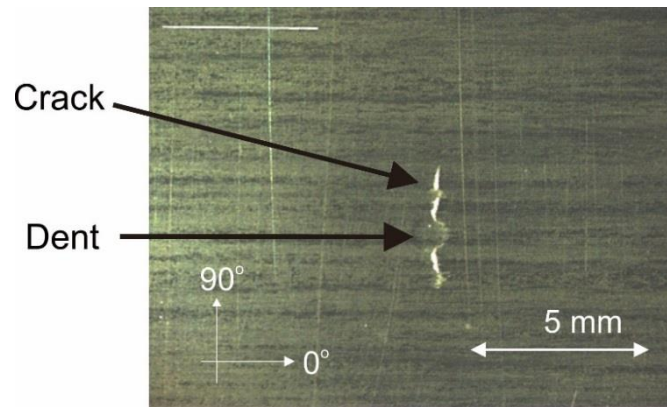
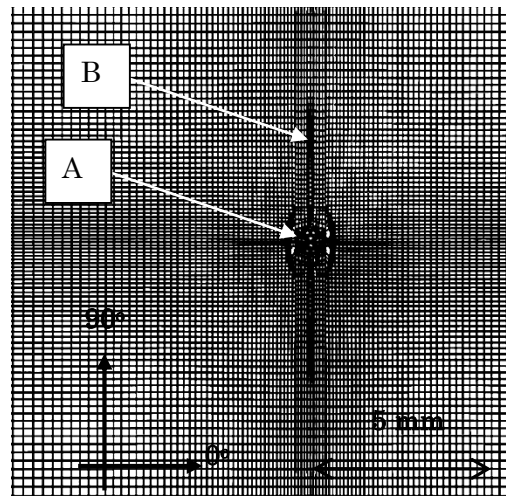
Figure 5.5: Damage on the front surface of the specimen 1 laminate after impact; (a) Experimental result, (b) simulation result [66].

Figure 5.5(a) depicts the damage states on the front surface of the laminate. The laminate has a dent with two fiber-breaking cracks propagating in the transverse ( $90^\circ$ -) direction, while any splitting cracks parallel to  $0^\circ$ -direction are not generated. A similar damage pattern is simulated as depicted in Figure 5.5(b) where the dent (arrow A) and cracks (arrow B) are generated on the front surface. These cracks (fiber breakage) are

ascribed to compressive stress in the 0°-direction, which causes buckling of carbon fiber.
