**CHARACTERIZATION OF MICROSCOPIC IMPACT DAMAGE IN  
CFRP LAMINATES WITH TOUGHENED INTERLAYERS**

A thesis submitted in fulfillment of the requirements  
for the degree of  
Doctor of Engineering  
in Graduate School of Science and Engineering  
Ehime University

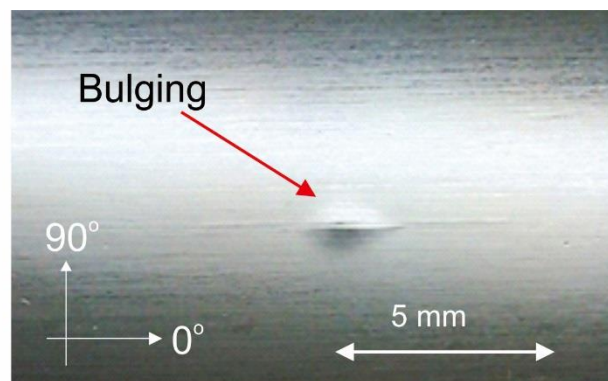
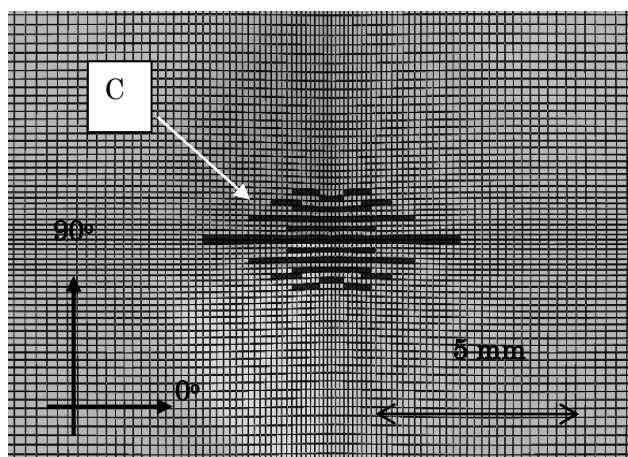
Figure 5.6: Damage on the back surface of the specimen 1 laminate after impact;

(a) Experimental result, (b) simulation result [66].

On the contrary, the bulging area is generated on the back surface of the laminate and the crack propagates in the  $0^\circ$ -direction (Figure 5.6(a) and arrow C in Figure 5.6(b)). The bulging is due to bi-axial tensile stress in the  $0^\circ$ - and  $90^\circ$ -directions due to global bending deformation of the specimen.

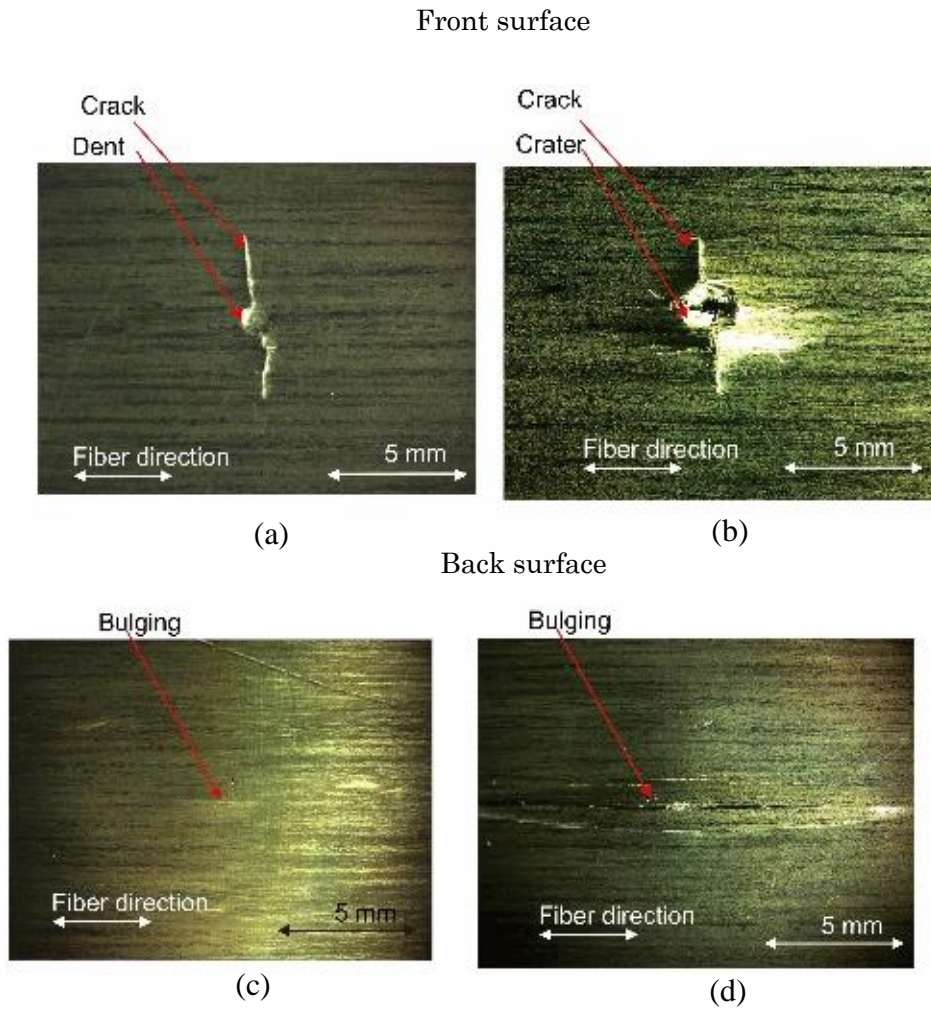
Figure 5.7: Damage on the front and back surface of the laminate after impact; (a) & (c): specimen 2; (b) & (d): specimen 3.

Similar damage pattern was observed at the front and back surfaces of the laminate for other impact energies as depicted in Figure 5.7.

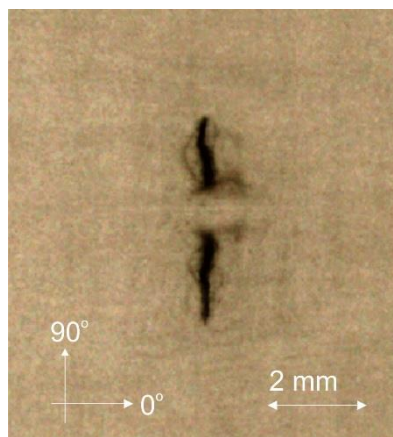
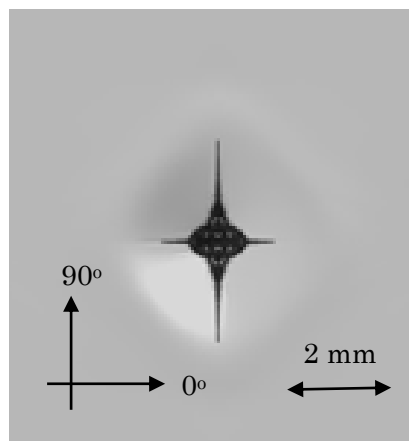
Figure 5.8: Delamination after impact of specimen 1; (a) Soft X-ray photograph, (b) simulation [66].

A typical soft-X ray photograph of the specimen 1 laminate is presented in Figure 5.8(a). The delamination propagates in both the  $0^\circ$ - and  $90^\circ$ -directions. This delamination pattern is fairly well reproduced by the simulation in Figure 5.8(b). Figure 5.9 demonstrates the simulated cross sectional view of the specimen after impact. Both the interlaminar (arrows D) and intralaminar delaminations (arrows E) are generated and

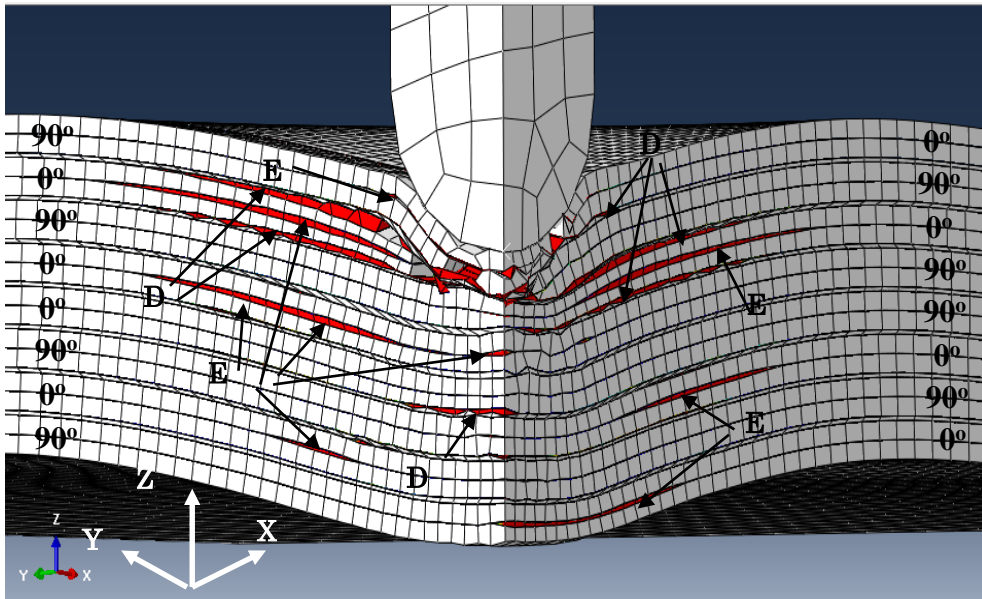
Figure 5.9: Simulated cross sectional view of specimen 1 showing interlaminar (arrows D) and intralaminar (arrows E) delaminations [66].

extend in both the  $0^\circ$ - and  $90^\circ$ -directions (X and Y directions in Figure 5.5). The delaminations are remarkable in the upper plies rather than in the lower plies. The same tendency is observed in the experiment (Figure 5.1(a)). Table 5.2 compares the projected delamination area between the experiment and simulation. It should be noted that this delamination includes not only the interlaminar but also the intralaminar ones inside the laminate. The delamination area is slightly overestimated partly because matrix failure inside the interlayers are not taken into account in the simulation.

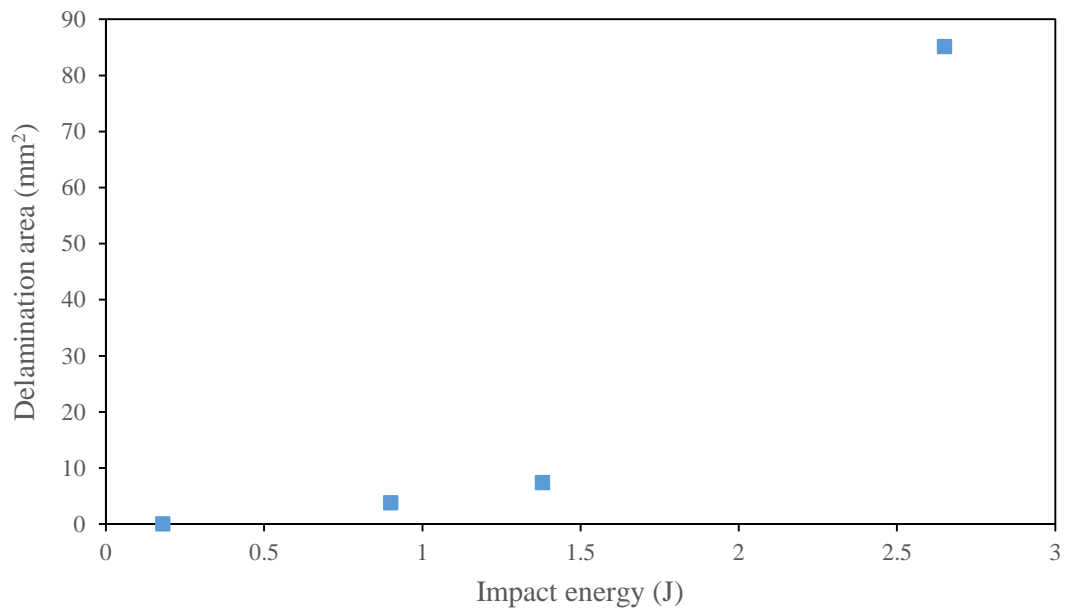
Figure 5.11: The delamination area is plotted against the impact energy.

In addition, the delamination area is plotted against the impact energy as depicted in Figure 5.11 and it indicates the delamination area increases with the increase of impact energy. Additionally, the threshold energy is approximately 0.18 J as stated in [65].

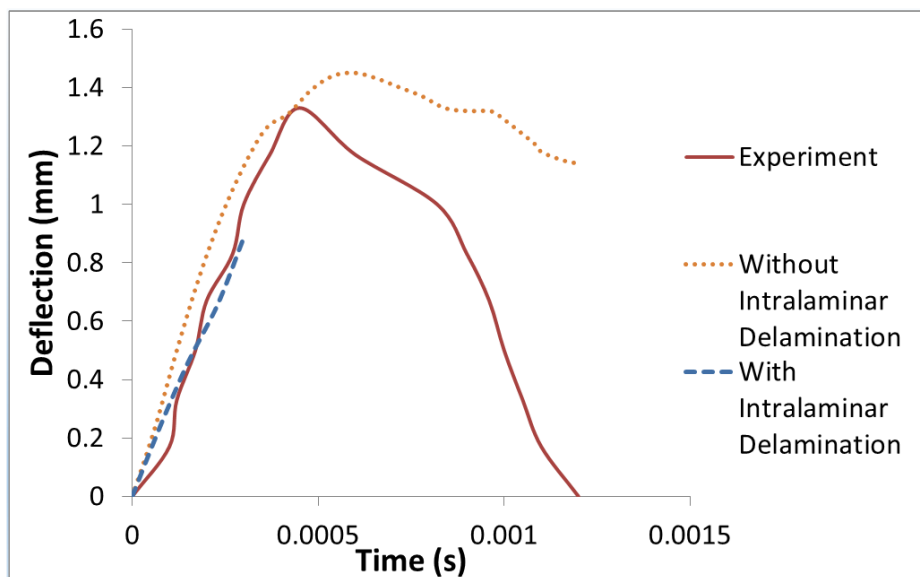
Figure 5.12: Measured and predicted time history of deflection of specimen 1 [66].

Figure 5.12 compares the deflection-time curve between the experiment result and the simulations with and without considering intralaminar delamination. The calculation in the former case was terminated before reaching the maximum deflection because the failed elements in the base plies are largely distorted. The deflection rate of the former case gives fairly good agreement with the experiment result up to 0.0003 s approximately. Since most of the damage are generated by this time, the simulation is successful as far as the damage prediction is concerned. As a result, it can be said that the prediction with intralaminar delamination provides better agreement with the experiment result.

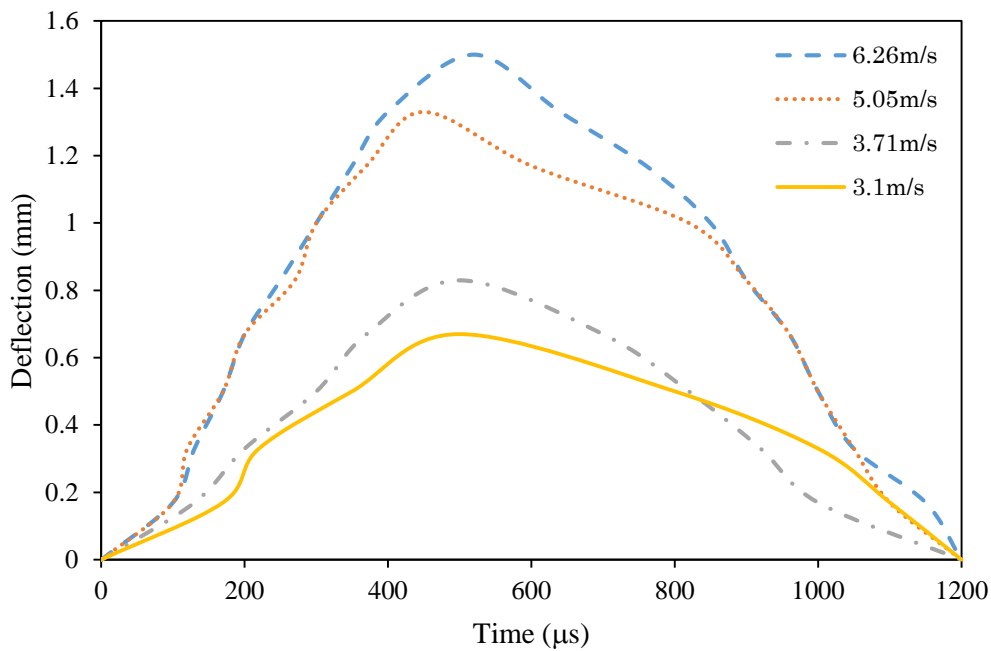
Figure 5.13: Time history of deflection via experimental characterization.

In addition, the deflection of the laminate for other impact velocities is plotted against

time graph in Figure 5.13. From the figure, the laminate deflects both in linear and non-linear trend. The deflection is at a faster rate as the speed of impactor increased and the maximum deflection occurs in between 0.4 ms to 0.5 ms.

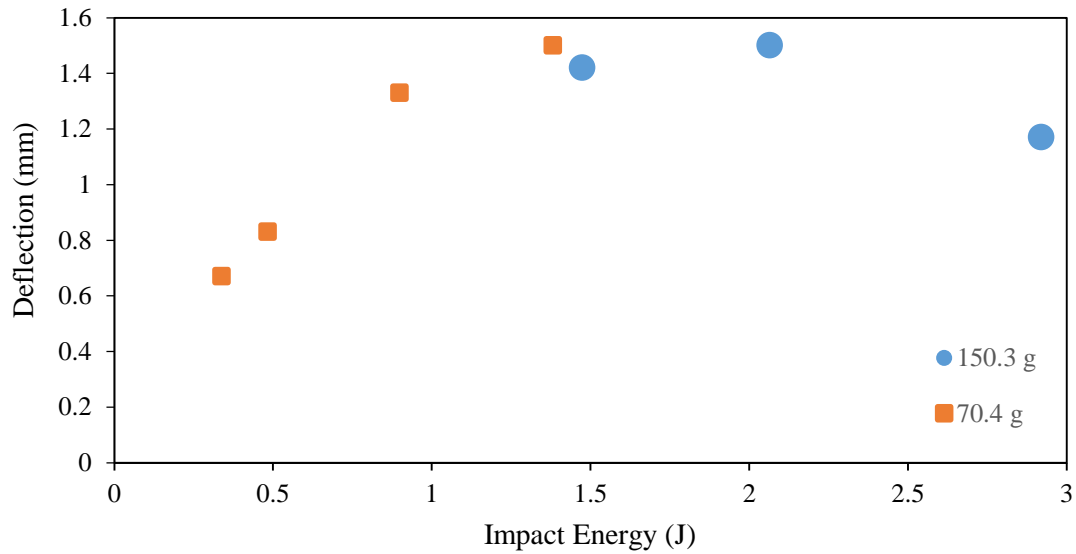
Figure 5.14: Relationship between deflection and impact energy for two masses; (a) 70.4g and (b) 150.3g.

Figure 5.14 depicts the maximum deflection at the center of the laminate after subjected to impact at different incident impact energy for two types of impactor masses. The deflection increases as the impact energy becomes greater. However, for the mass of 150.3 g, the deflection decreases at the impact energy of 2.92 J due to penetration on the laminate.
